The advantages of a zirconia collar

Massimo Palermo presents a recent case study with a six year follow-up.

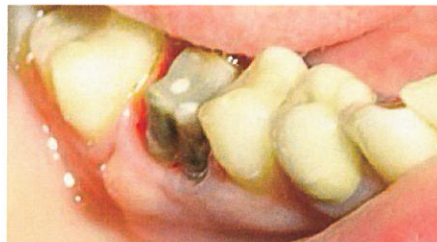
Fig 1.

In May 2013, a 46-year-old female patient presented with an infection (fig 1) near the apex of the LR6 tooth root. A treatment plan was formulated and discussed with the patient, which involved extraction of the LR6 and placement of a 4mm diameter by 10.5mm length TBR Z1 dental implant.

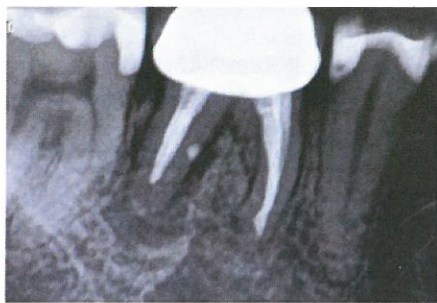
Fig 2.

A radiograph (fig 2) was taken which showed that the patient had insufficient bone quality and quantity, as the top of the cortical bone was not level. In order to preserve the socket, extraction of the LR6 was performed and a collagen sponge made of lyophilised non-denatured type-I collagen extracted from equine Achilles' tendon (Condress) was placed, in order to encourage accelerated healing of the supporting bone so that an implant could be placed.

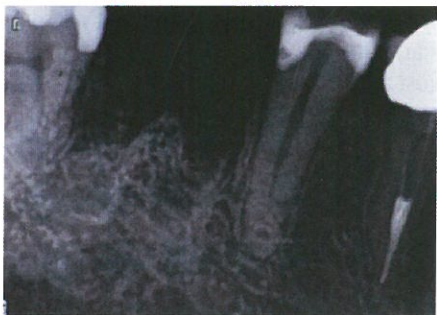
Fig 3.

Five months following extraction, a radiograph (fig 3) taken in preparation for implant placement demonstrated imperfect bone levels, despite the socket preservation procedure. The decision was therefore made to perform guided bone regeneration (GBR) at the time of implant placement.

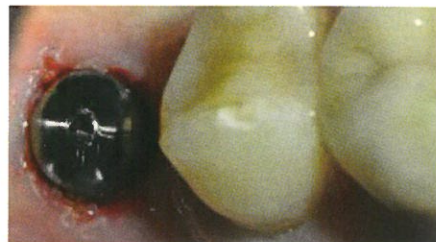
Fig 4.

Having later achieved excellent bone and soft tissue regeneration, a second surgical step was required. A circular opening was created with a diode laser so that the healing abutment (fig 4) could be placed. While this second surgical step is not normally indicated when using the Z1 implant – the gingiva usually grows around the transgingival zirconia collar naturally – it was

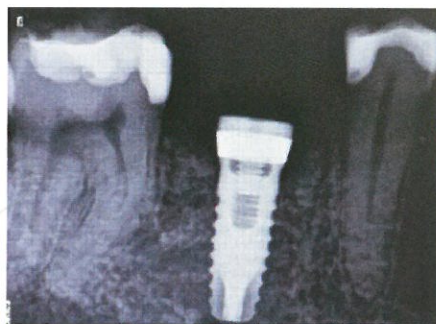
Fig 5.

Six months post-implant surgery, a radiograph (fig 5) demonstrated excellent bone growth that fully supported the implant. Figure 6 shows that the implant had healed well with no sign of infection or gingival inflammation. The Z1 implant facilitated enhanced healing of the gingiva, particularly around the zirconia collar.

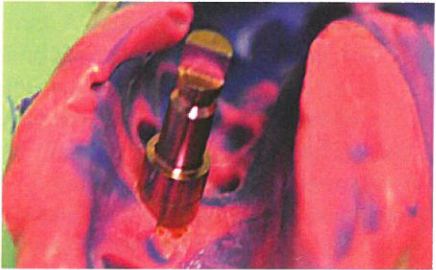
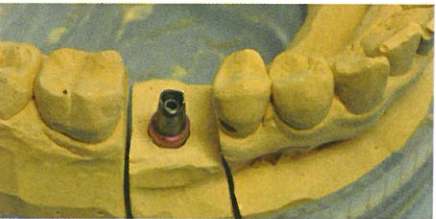
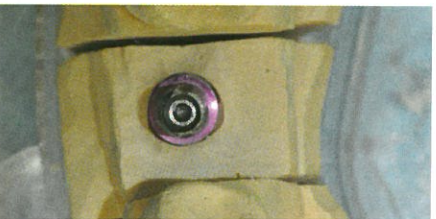
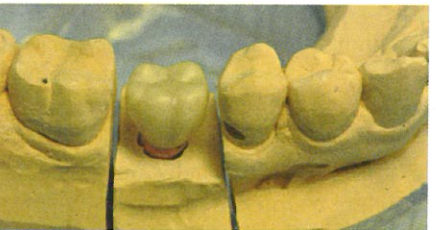
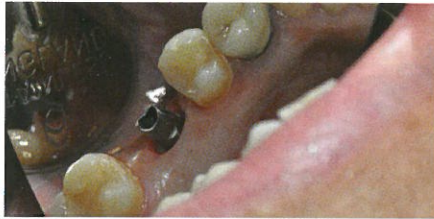
The healing cap was removed in order to fit a TBR Swiss clip direct impression coping (fig 8). This does not involve the use of a screw and is a simple, quick impression-taking solution that combines the benefits of both direct and indirect techniques. In particular, it is ideal for closed-tray methods involving single-unit implants, meaning clinicians do not have to rely on a customised tray. An impression (fig 9) was then taken, which was sent to the laboratory technician to create a model (figs 10 and 11). The technician fabricated a zirconia crown (figs 12 and 13) which was sent back to the practice for a try-in with the patient to ensure a satisfactory fit (figs 14-18).

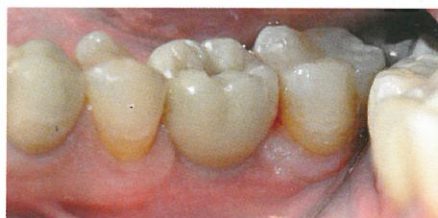
Fig 19.

Following completion of treatment, the zirconia collar implant provided results comparable to a natural tooth. As figure 19 demonstrates, the emergence

Profile of the implant was very good and looked like the adjacent natural gingiva. Two radiographs were taken – one in 2018 (fig 20) and the other in 2019 (fig 21). Both of these showed the same result, five and six years respectively, following implant placement. In fact, the peak of the bone near the collar is in the same condition as when the implant was first placed. There is excellent gingival integration (fig 22), with no bone resorption near the zirconia collar.

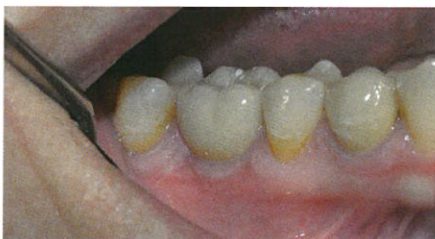
Fig 22.

An increase in keratinised gingiva can be seen just below the coronal margin at the level of the implant's zirconia collar. Evidently, the patient had very good oral hygiene to help maintain a healthy implant, but this is not the only reason for lack of bone resorption and gingival recession. The design of the Z1 implant helped to ensure
