Use of biocompatible materials for enhanced aesthetics and soft tissue stability after implant treatment

Fabrice Baudot examines how a challenging case to achieve an aesthetic outcome in can still be successful as long as the patient is satisfied

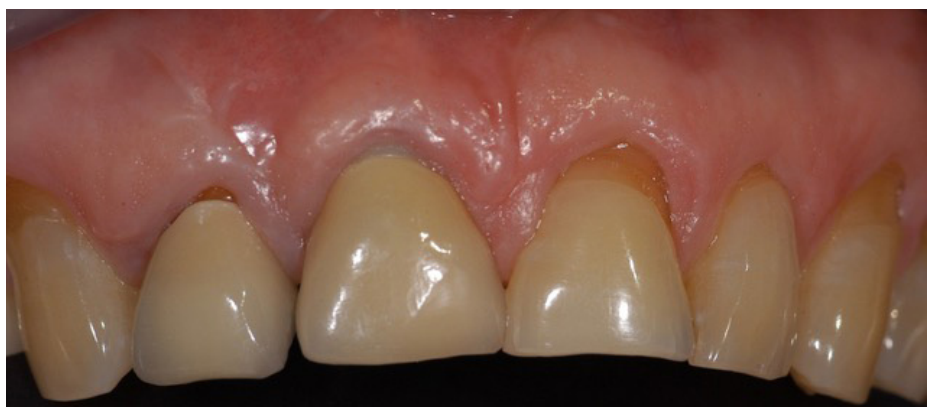
In time, the biological behaviour of the transgingival portion of the implant is improved and we would therefore expect to see the papillae naturally grow to reduce the visible amount of zirconia.

This can be seen in the nine-year follow of this case outlined (Figure 19) showing once again the benefits of the Z1 zirconia collar implant from TBR.

Figure 19: At the nine-year follow up the papillae has grown to reduce the amount of visible zirconia
